L5 CAMERA IP TROUBLESHOOTING GUIDE

This guide describes the troubleshooting process for finding and correcting the IP address of an L5 camera whose IP address is not found on the default 192.168.3.100 - 106 subnet range. This can cause the camera to not appear in CDM, CDF, or MiniCC and cause loss of the video stream.

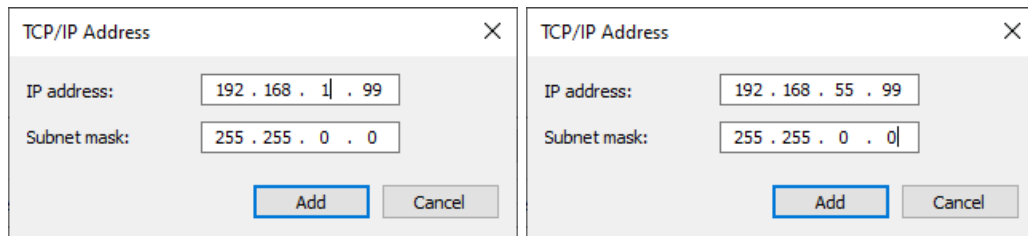
7. Click **Add** in the IP addresses section and enter the following IP address and subnet mask:

- **IP:** 192.168.1.99
- **Subnet:** 255.255.0.0

8. Click **OK**. Click **Add** again and enter a second IP address and subnet mask:

- **IP:** 192.168.55.99
- **Subnet:** 255.255.0.0
